INTEGRATION of SHAHJAHANABAAD and NEW DELHI

Gender Safety Audits for Public Spaces

Proposals for Safe Urban Spaces

Gender Safety Audit

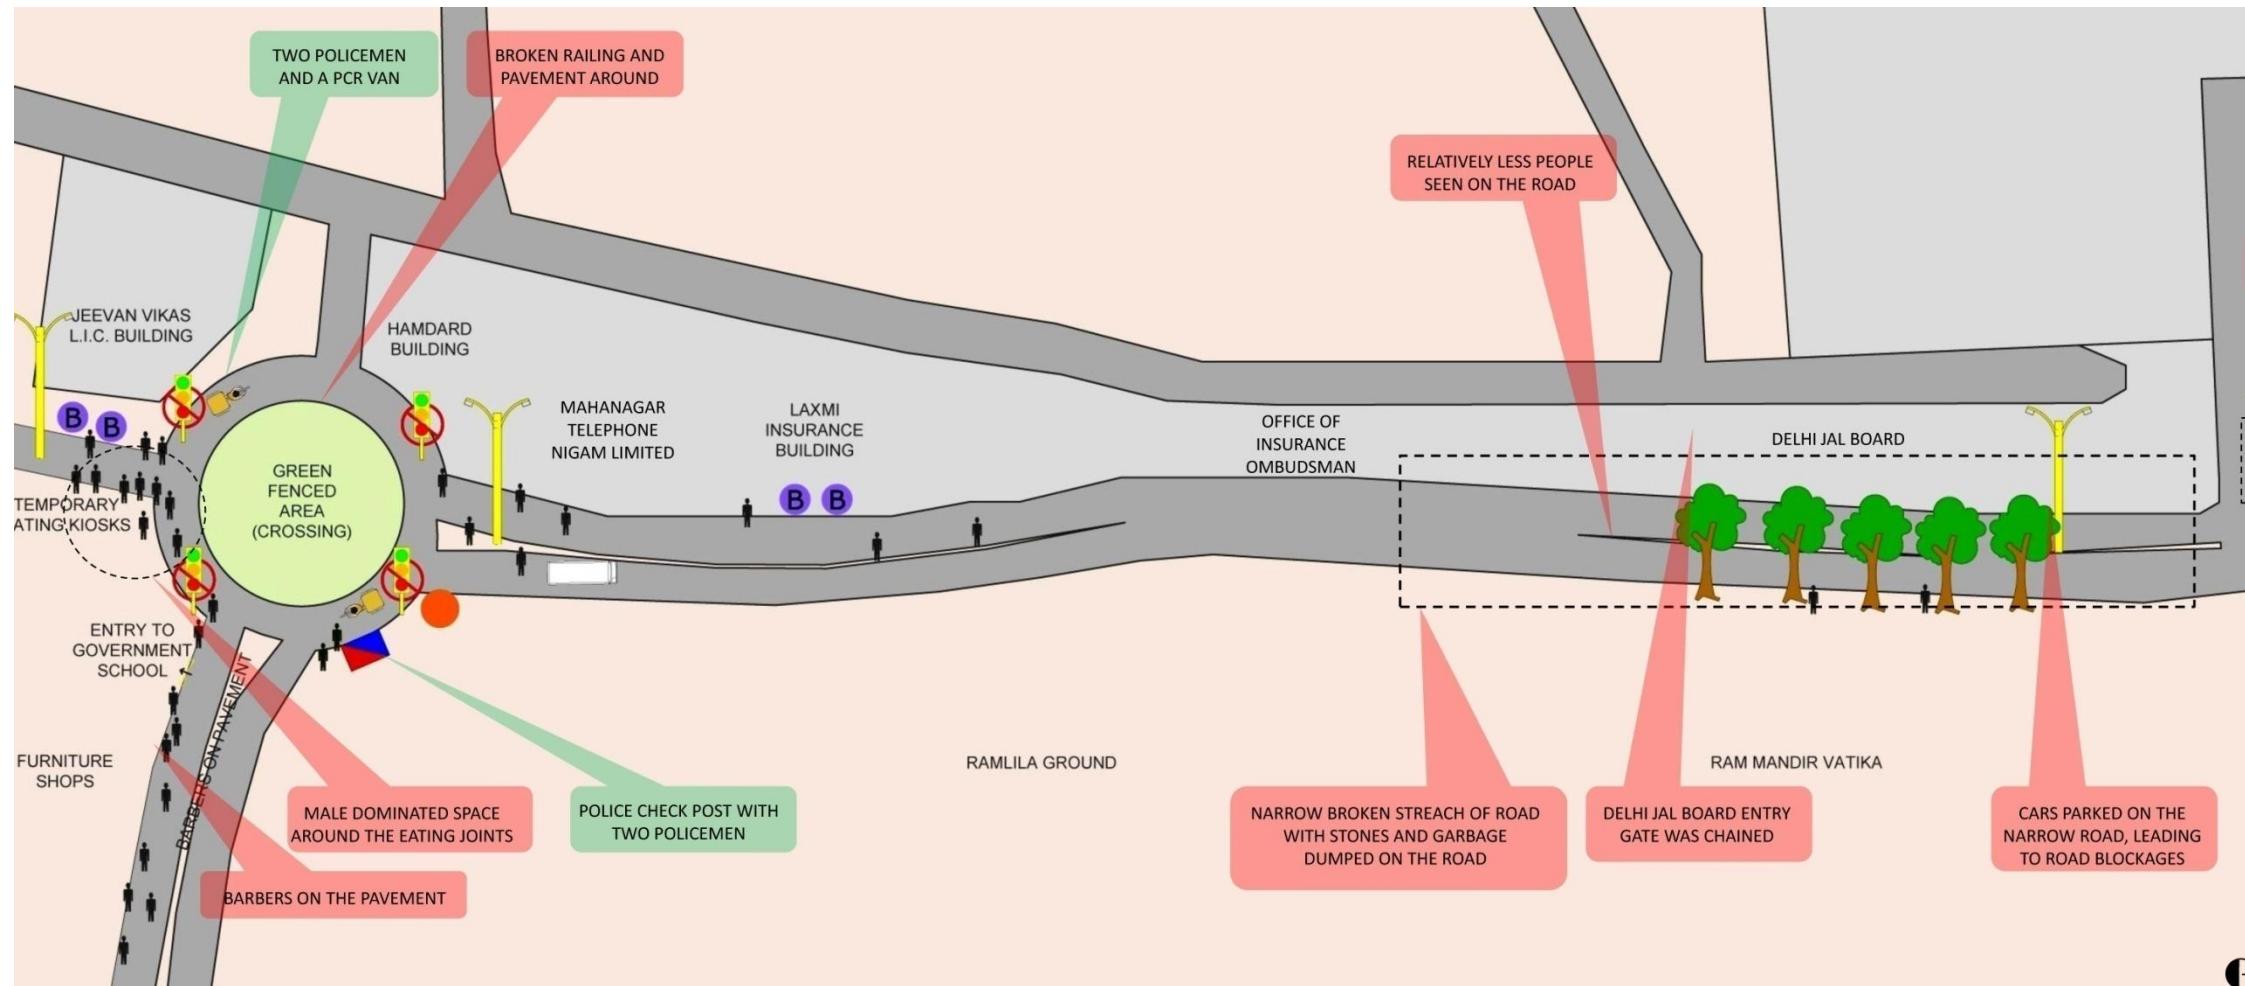
Humdard Chowk Junction to Delhi Jal Board

- Shift from high traffic zone at the junction to low traffic near the Delhi Jal Board.
- Important offices located in the vicinity .
- Lots of temporary food kiosks can be seen around the junction.

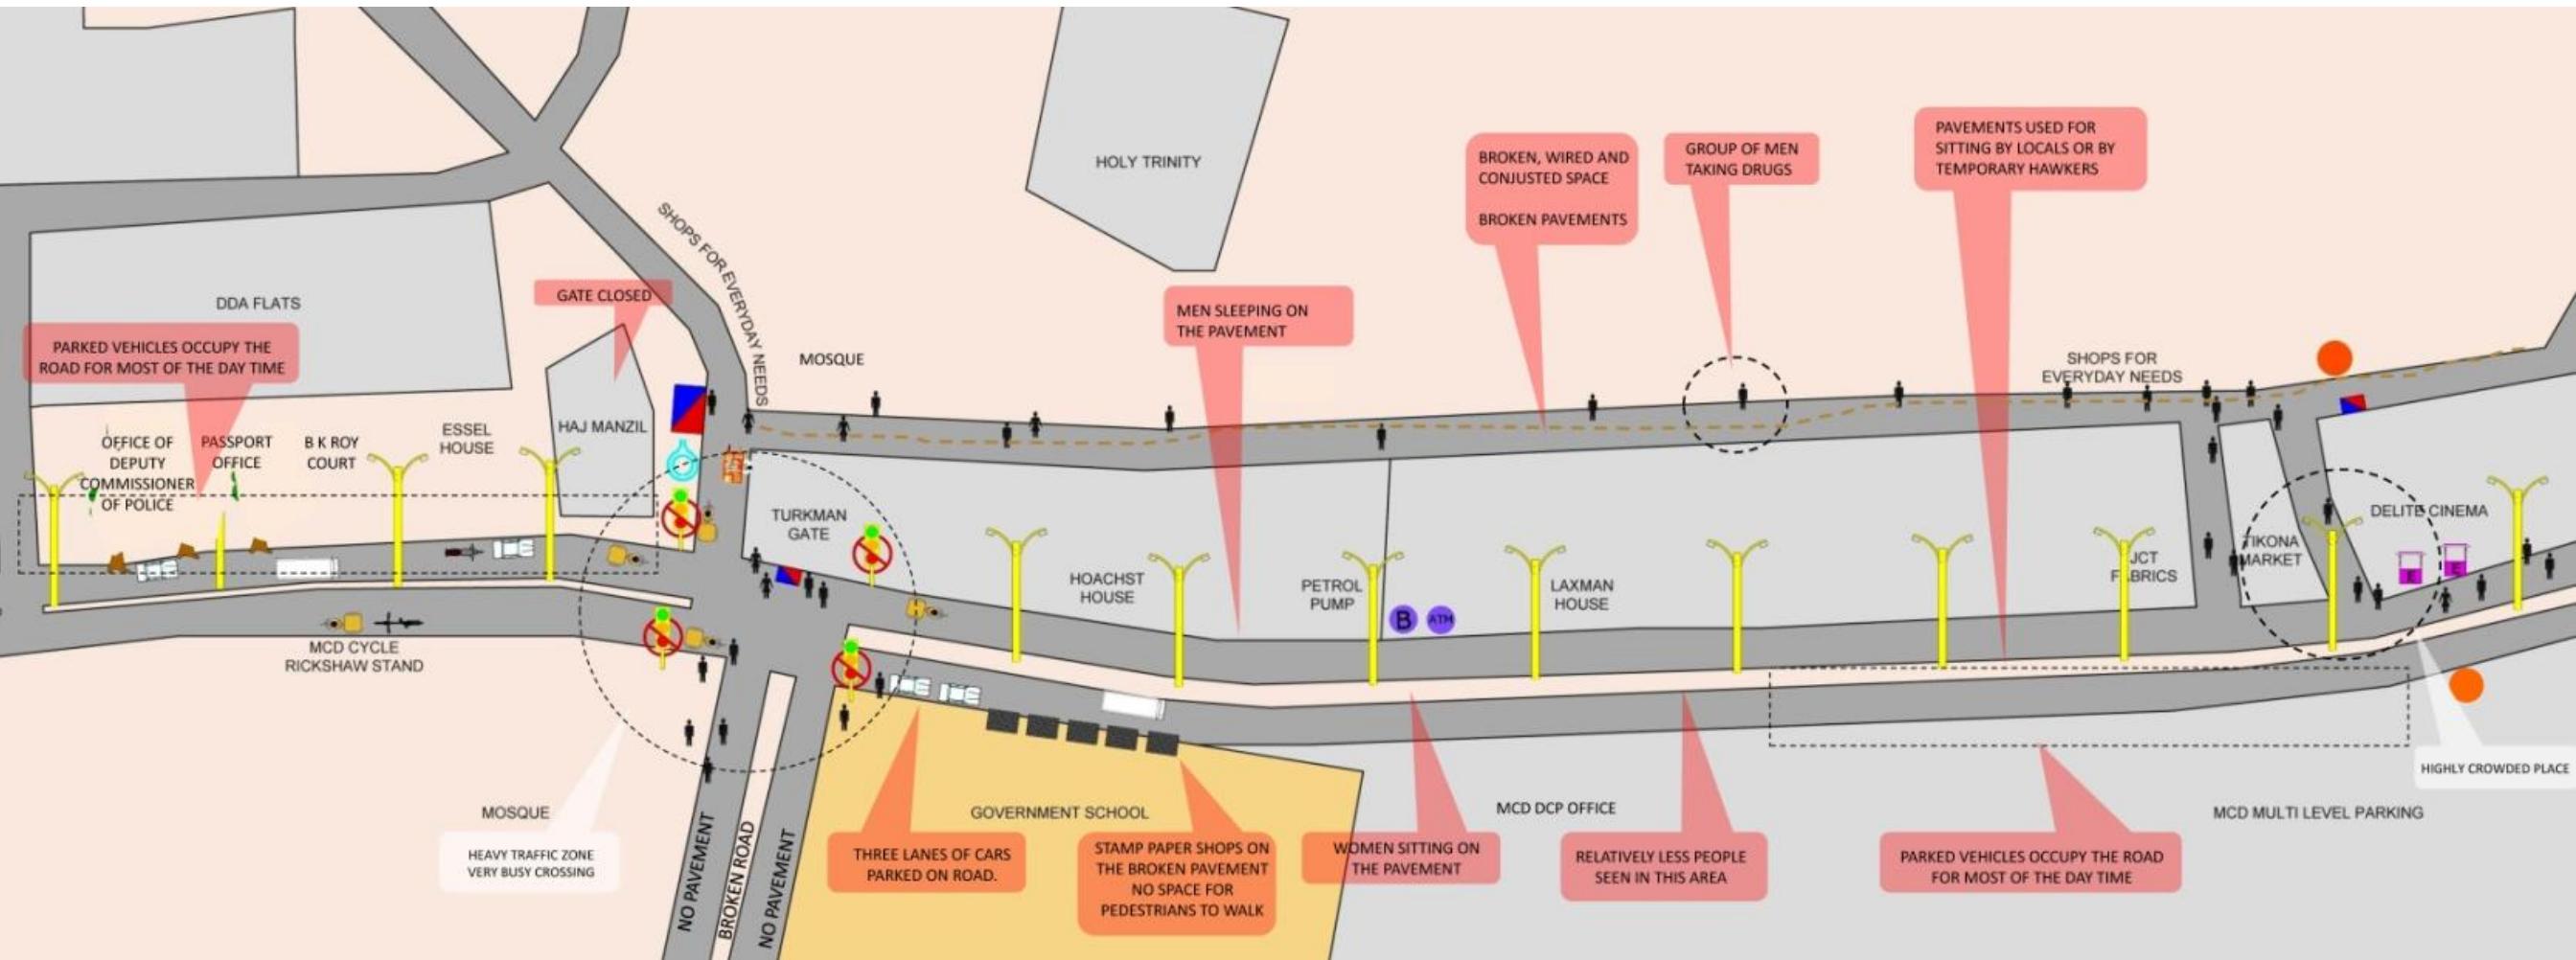
Turkman Gate Junction to Delite Cinema

- High traffic on this stretch.
- Parked vehicles and permanent kiosks selling stamp papers can be seen on the road sides.

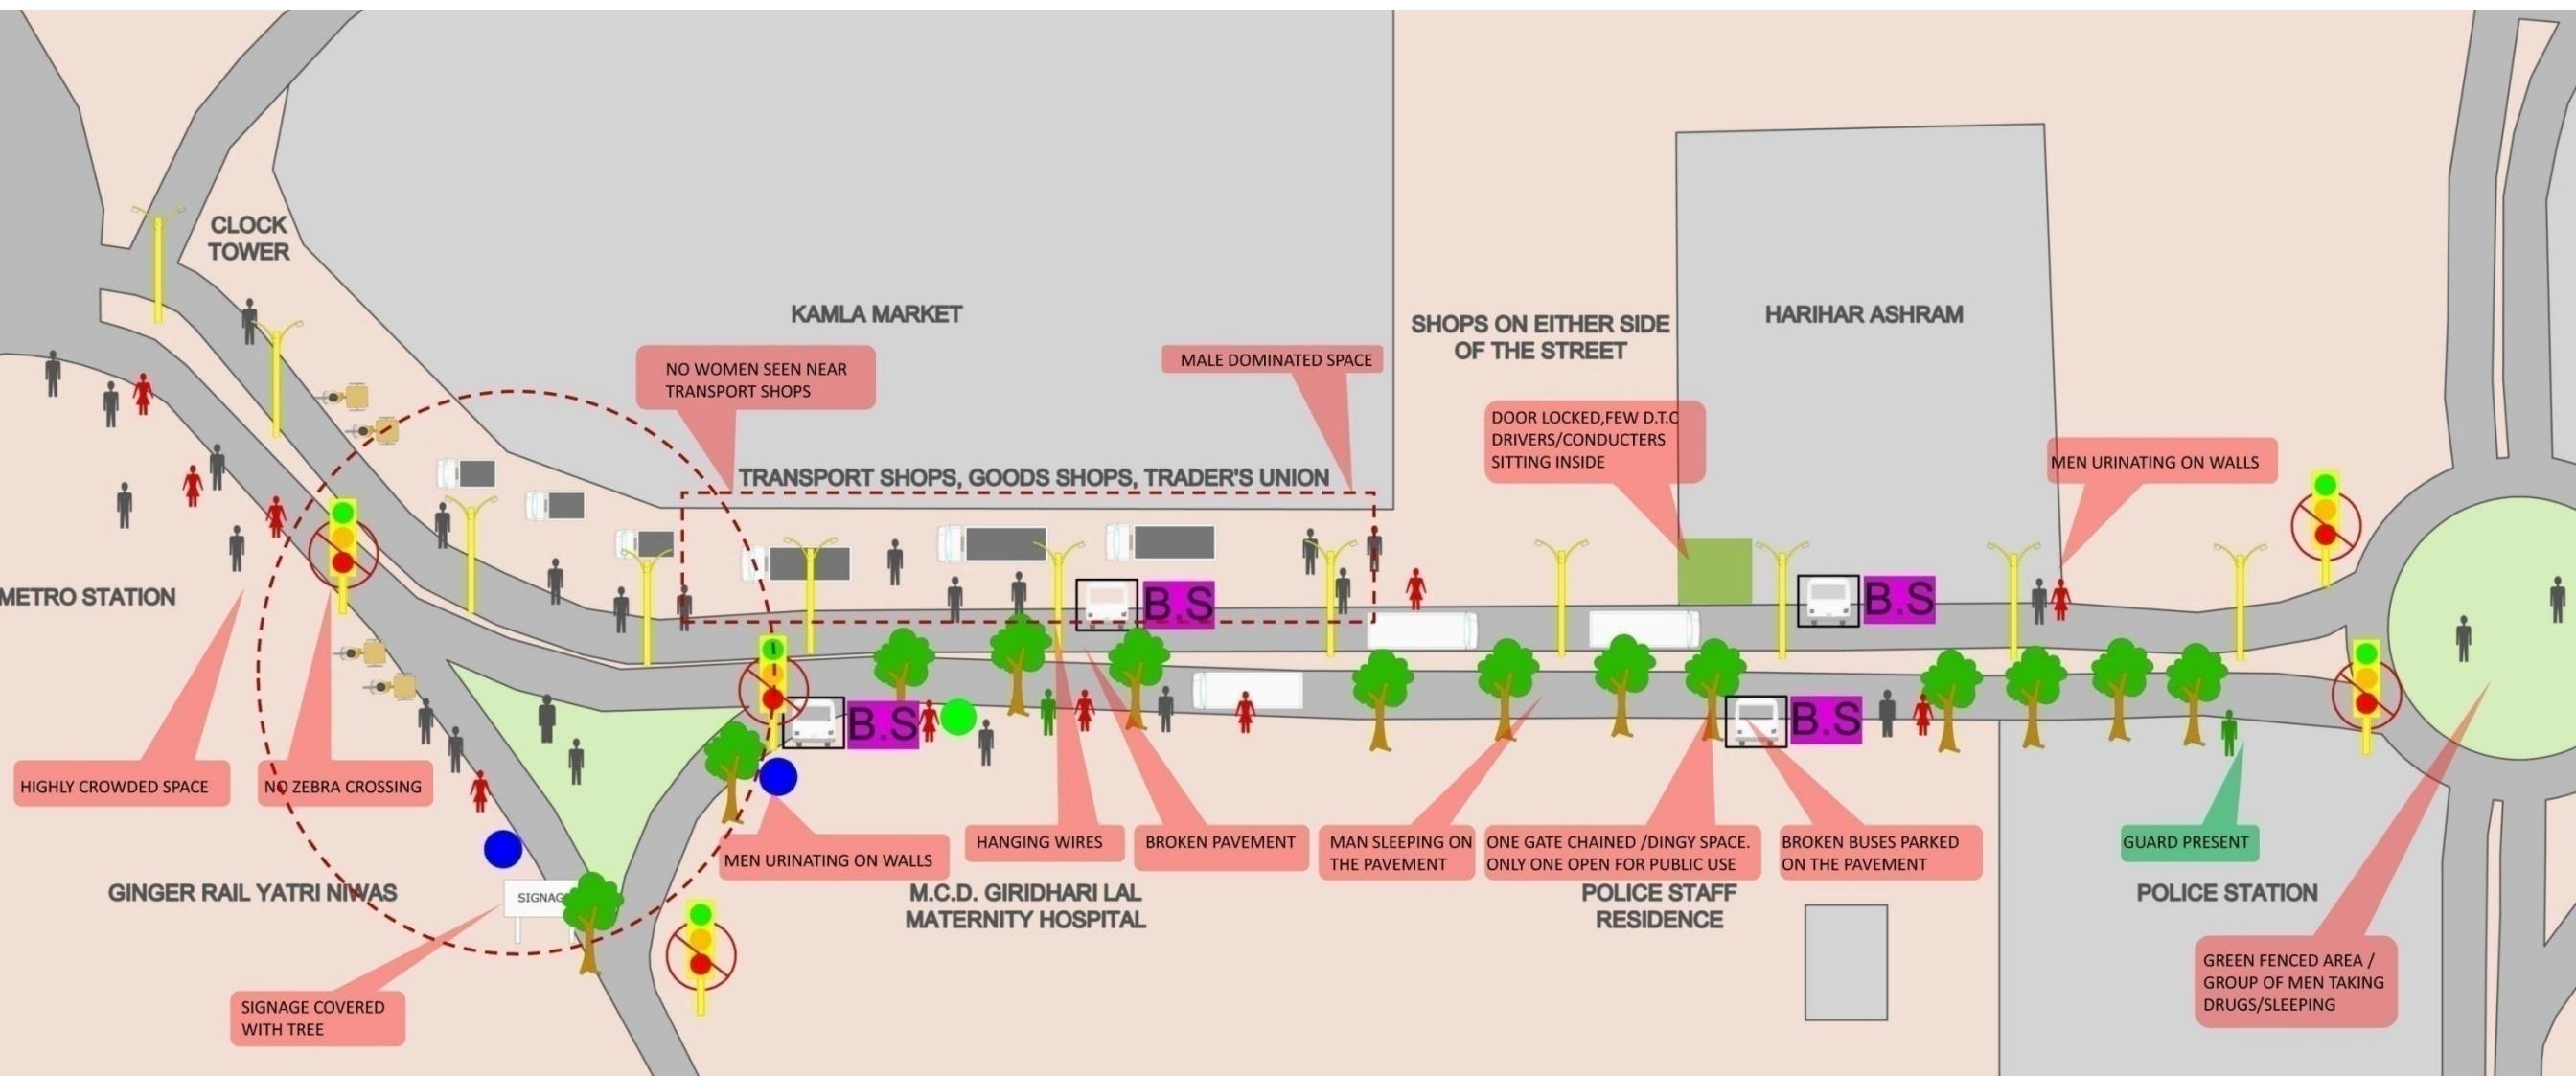
Kamla Market Junction

- High traffic area.
- Trucks and tempos parked near the market for transporting goods.
- Presence of Metro Station adds to the human traffic

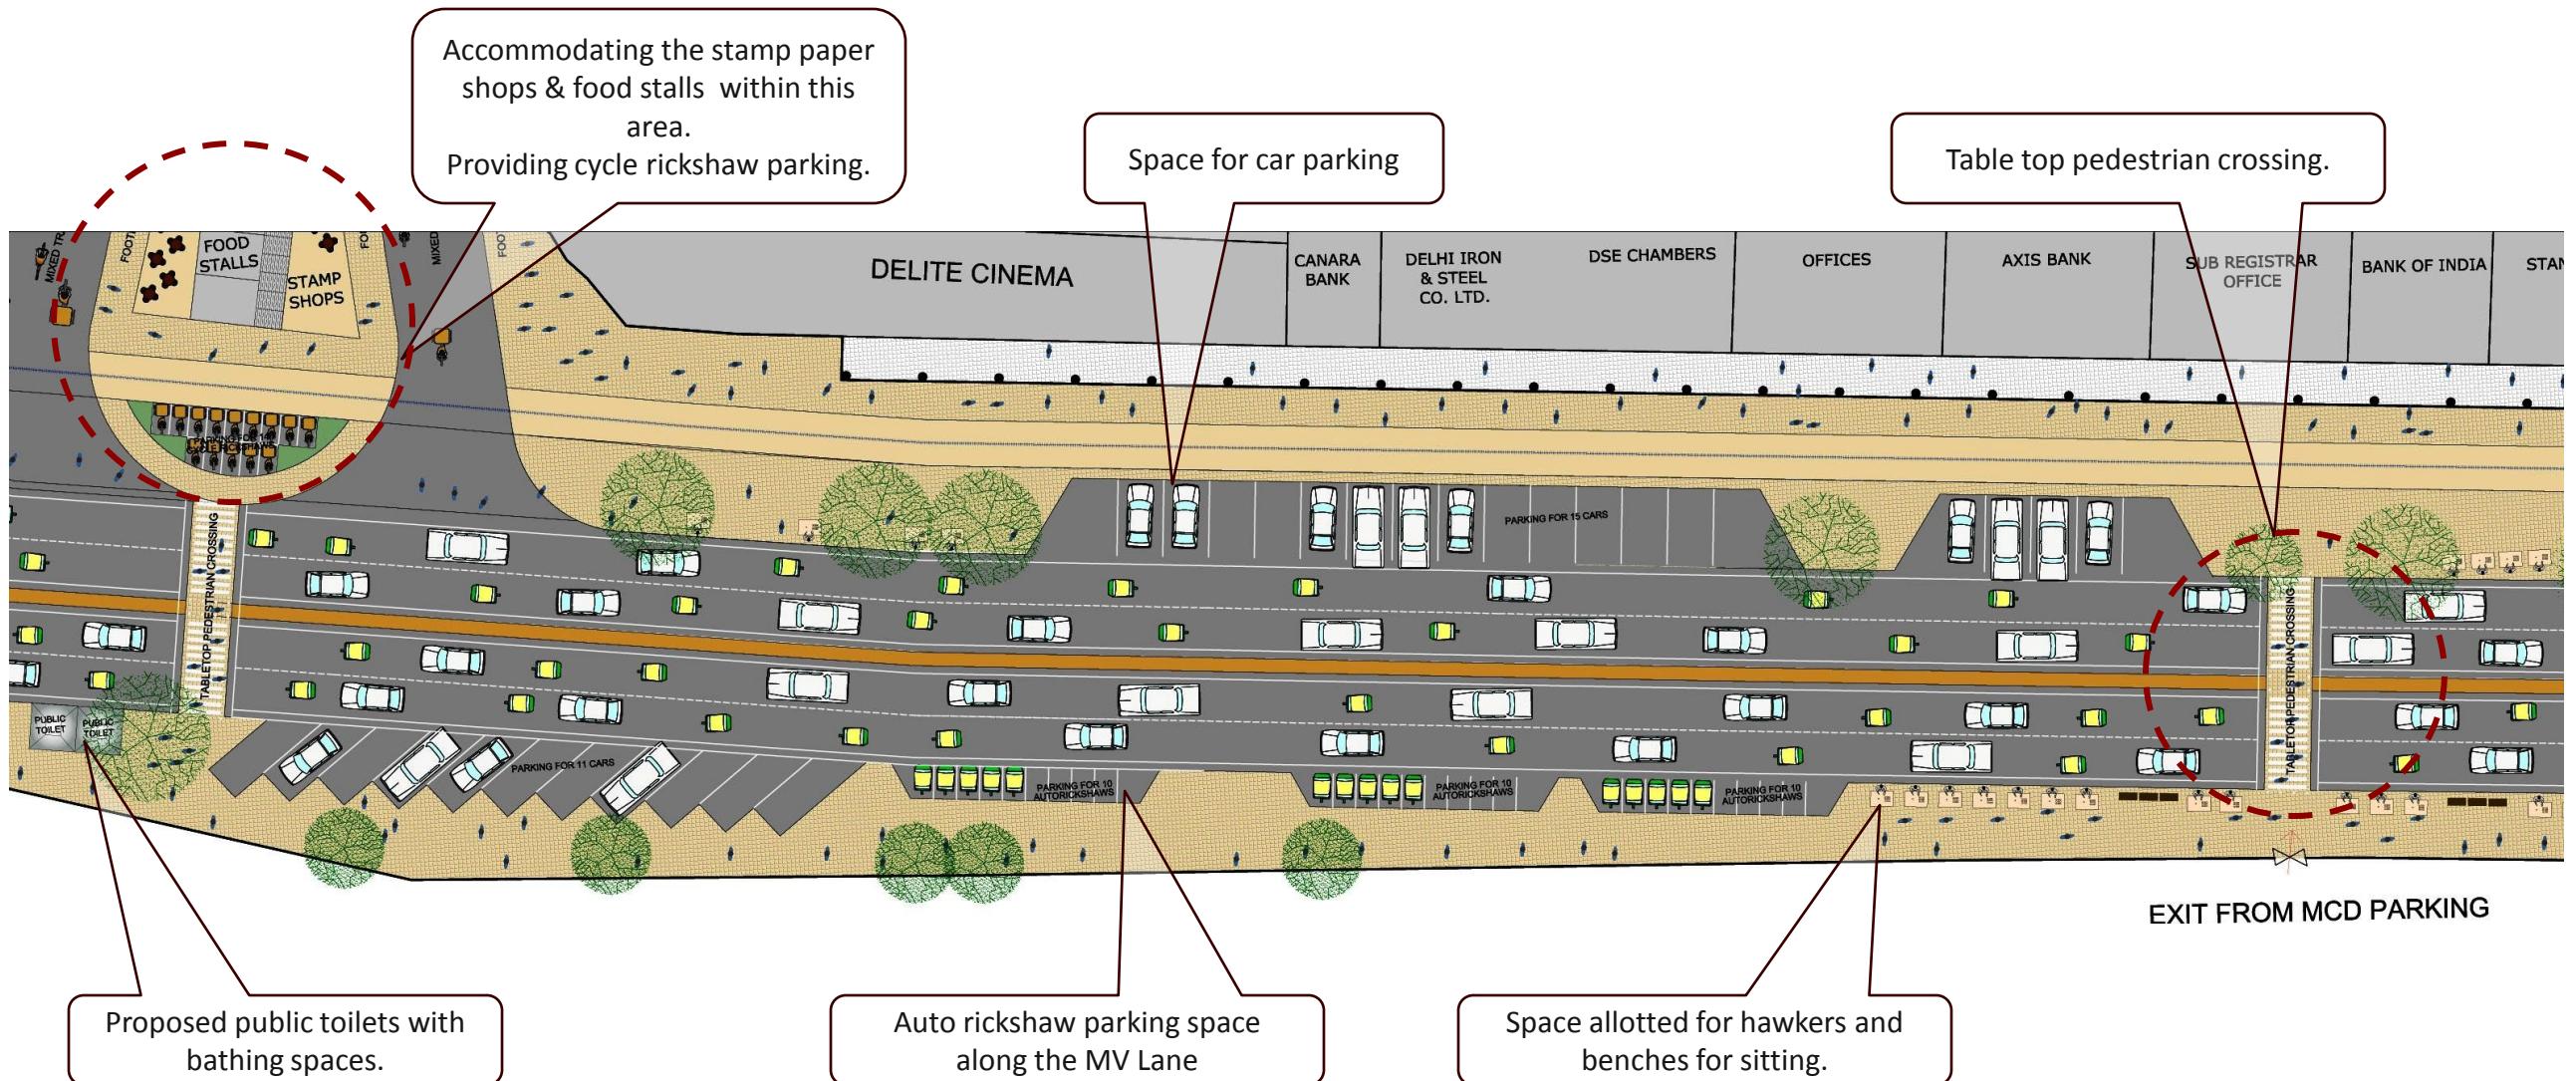
Area Around Delite Cinema

- 2.5mtr wide footpath provided on either side of road
- Wide activity zone or public realm
- Activity zone contains car, auto rickshaw, cycle rickshaw, two wheeler parking
- Space allocated for hawkers.

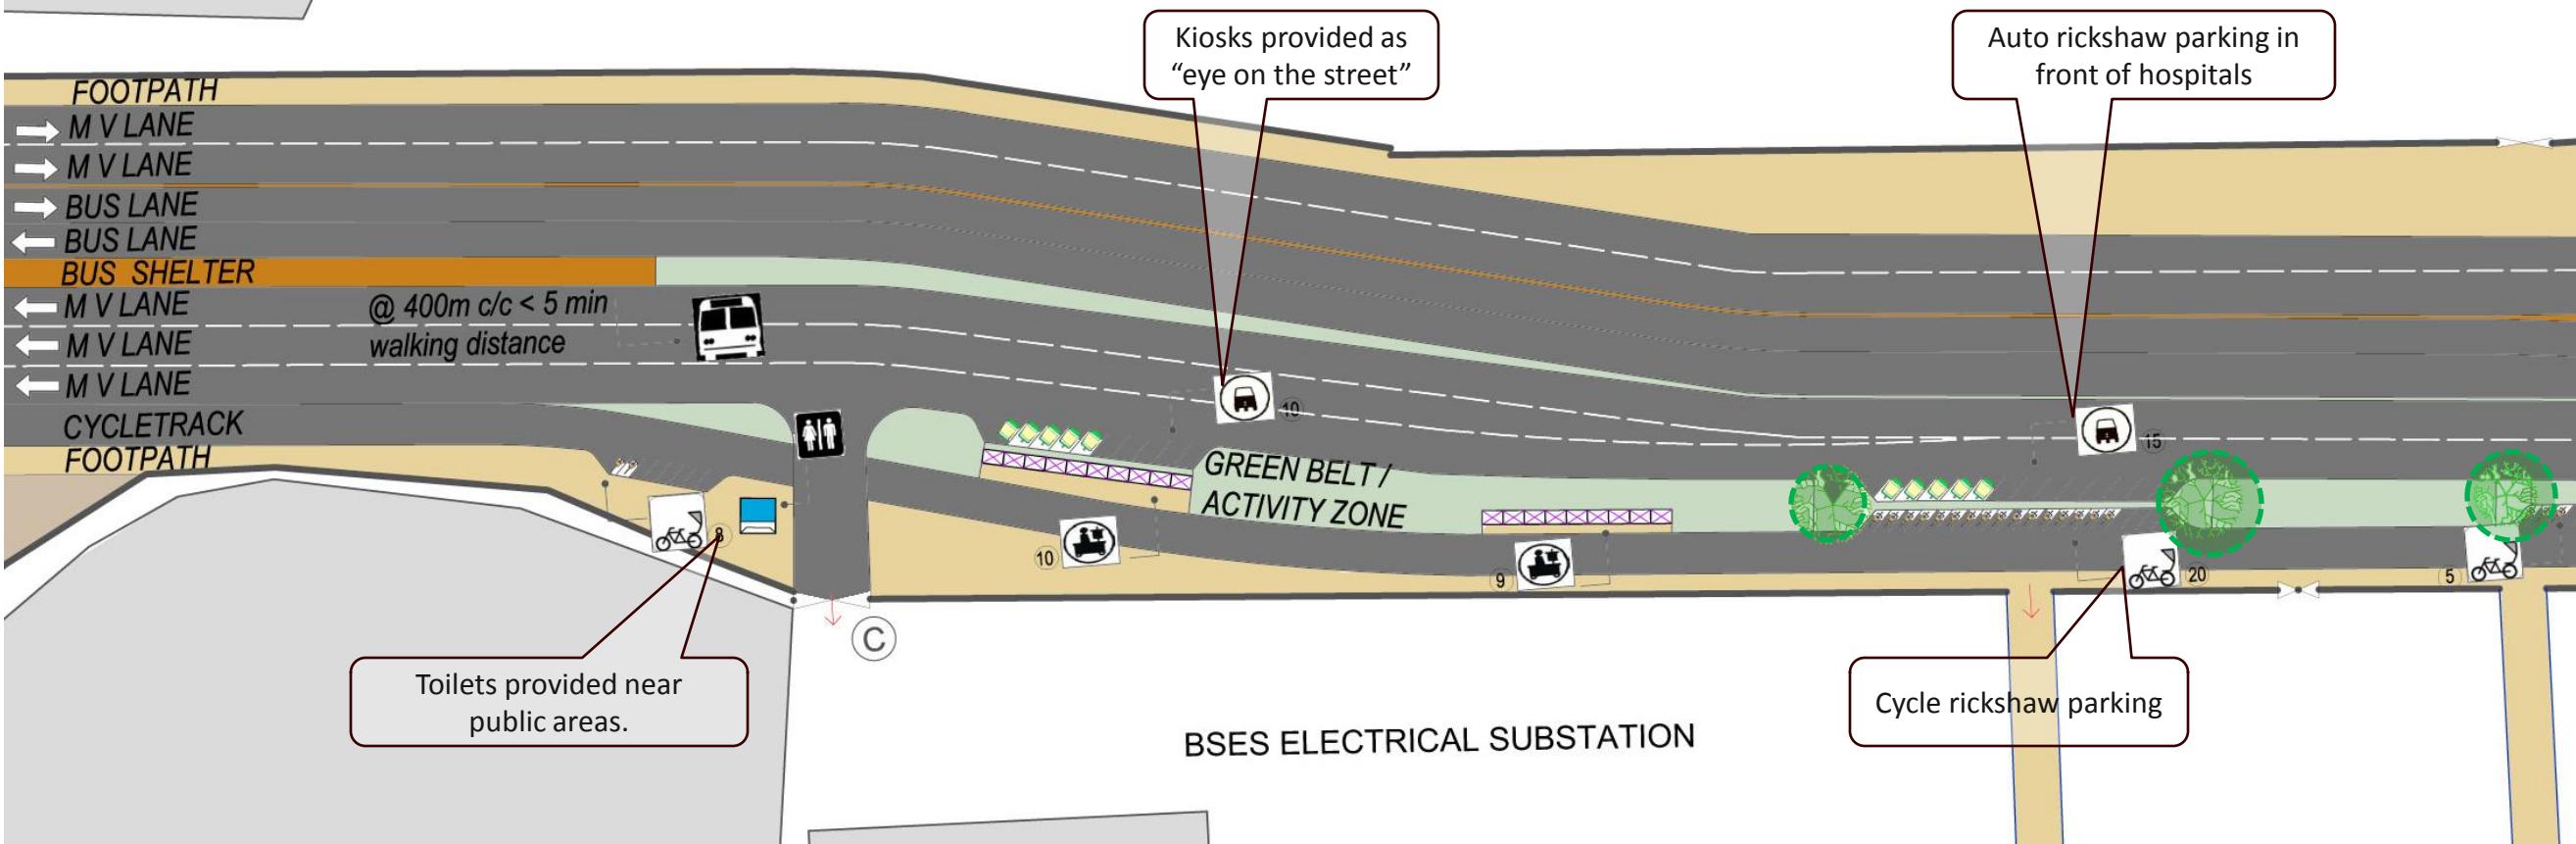
Infront of LNJP Basti

- 2.5mtr. Footpath provided on either side
- Wide two way cycle track on one side
- Activity zone for mixed use like kiosks, auto rickshaws, cycle rickshaws, green areas etc.
- 3.3mtr. Wide MV lanes

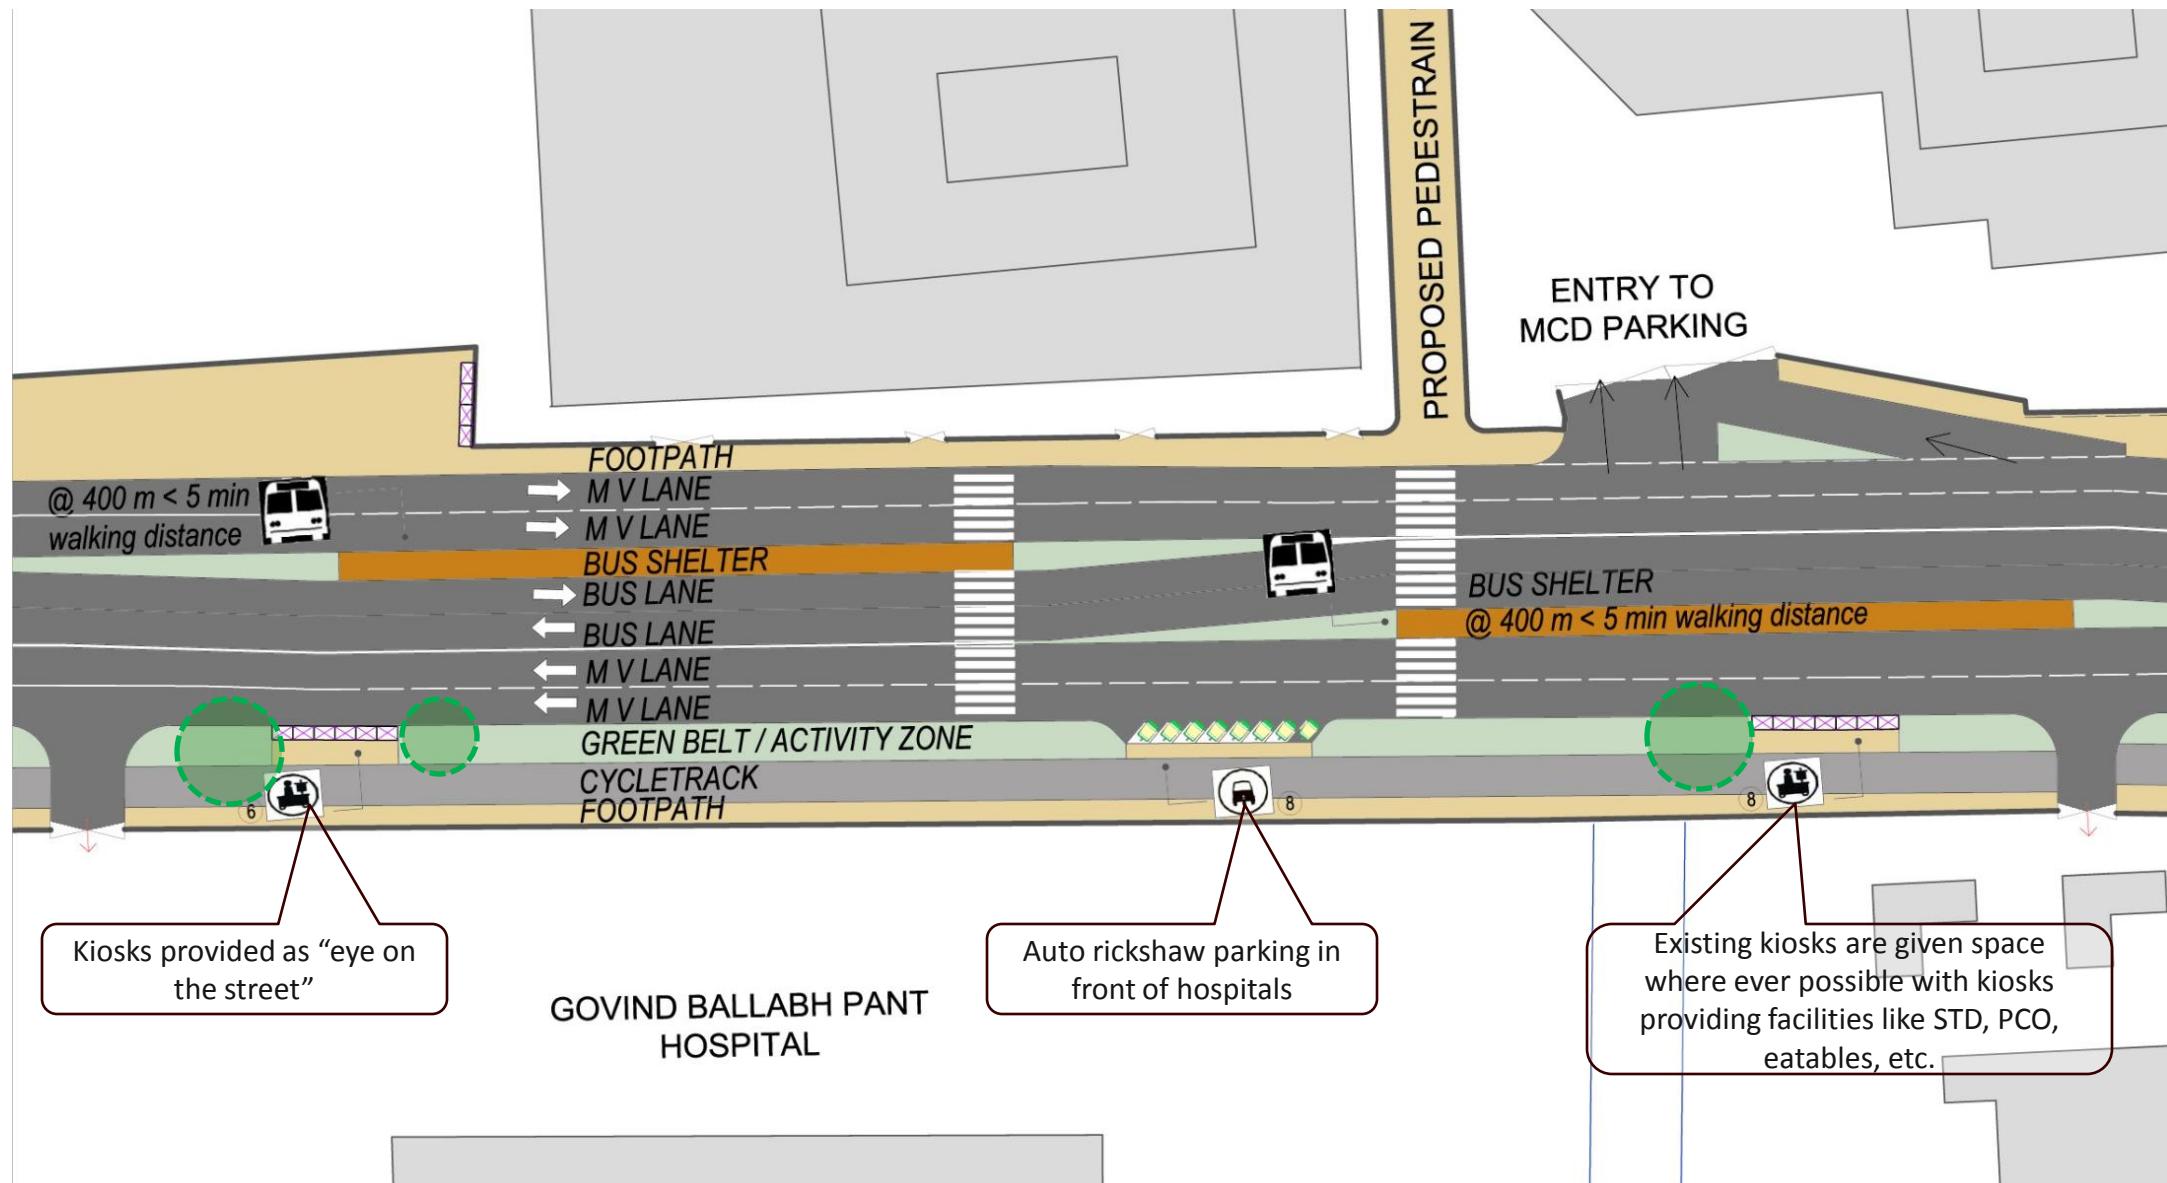
Infront of G B Pant Hospital

- 2.5mtr. Footpath provided on either side
- Wide two way cycle track on one side
- Activity zone for mixed use like kiosks, auto rickshaws, cycle rickshaws, green areas etc.
- 3.3mtr. Wide MV lanes
